Slating, tiling and roof plumbing

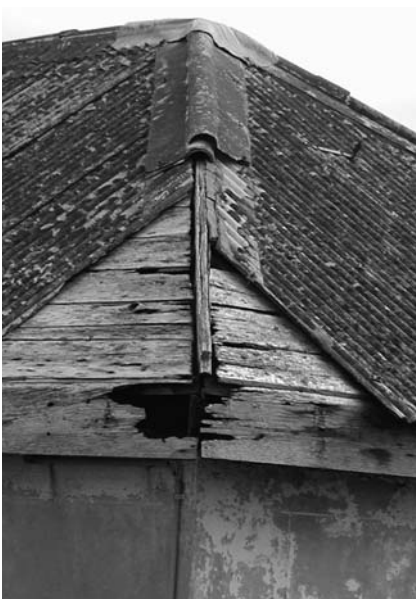
Removal of part of the roof on the keeper's cottage at the South Solitary Island Light Station has revealed the sarking beneath. The roof was formerly slate, and was replaced with corrugated asbestos.

Sarking (a waterproof underlay to the roofing) did not come into general use until recently. However, many early slate roofs had timber boarding over the roof structure to act as a secondary barrier to water entry, as well as cross-bracing for the roof. Provided the slope of the roof is adequate for the weather, sarking is still not essential for watertightness, but is a sensible second line of defence against roof leaks. It should be placed between the battens and the rafters. Sarking should only be used where there is no boarding, and where all the battens need replacement and have therefore been removed.

Early sarking was made of a bituminous material which is highly flammable. Unless the existing sarking is sound and of heritage significance, it may be desirable to replace it with a modern fire-resistant type.

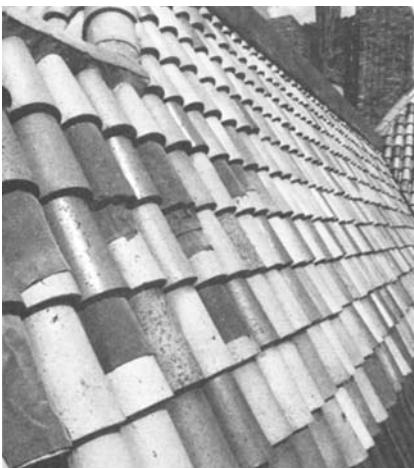
Traditional colour variations in terracotta tiles.

Old terracotta tiles were made in stack kilns in a similar way to bricks. The process resulted in different degrees of firing, those tiles closest to the fire being overburnt and those furthest underburnt. When glazed tiles appeared, there were more variations in the thickness of salt glazing, which was applied by hand. The manufacturing process thus resulted in natural variations in the colour of the tiles, and accounts for the motley colours of a traditional terracotta roof. Modern terracotta tiles are made in a tunnel kiln using highly controlled composition and temperature, and emerge very uniform in colour. They may therefore not be suitable for re-roofing an old building.

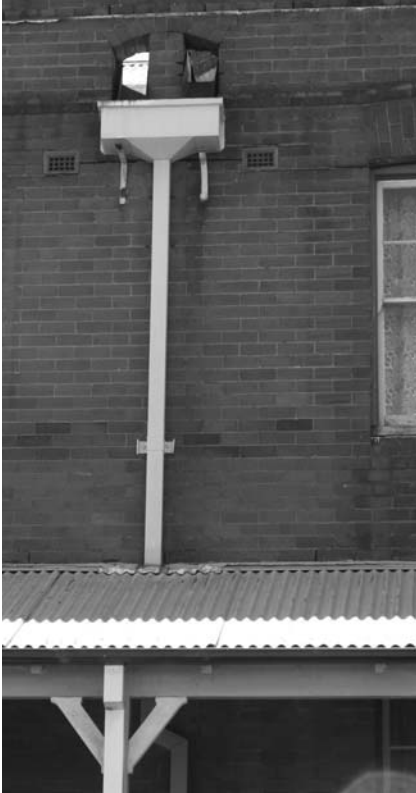
*Traditional rainwater head,
Gloucester Street, Sydney.*

Those elegant boxes at the top of downpipes are not just pretty decoration. The purpose of the rainwater head is to provide a large catchment area to slow and dissipate the energy of the horizontally moving water from the gutters. Gravity then takes over and the mass of water in the head drives the water down the downpipe much more effectively than without a head. Repair and maintenance of rainwater heads is therefore good building management practice as well as good conservation.

Rainwater heads should always have an overflow spout, so that in the event of blockages excess water is directed away from the walls below. They should also have wire mesh covers or baskets in a design that will not encourage bird nesting.
